DIGITAL DASH CLUSTER

1984-1987 BUICK REGAL and RIVIERA

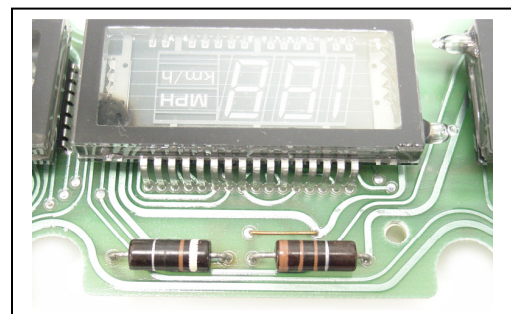
This is a “new” display board showing what the resistors should look like when soldered correctly. No solder joint discoloration here.

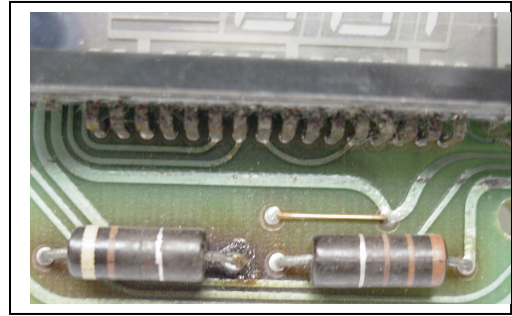
Over a course of time and temperature extremes, components on these dash clusters had a tendency to fail, causing many different problems to surface. A common problem is when one or more display segments go dim intermittently, or off completely. This is almost always caused by a pair of overheated resistors soldered to the display PC board. The purpose of the resistors is to limit the display filament current (they are actually vacuum tubes).

Because of the excessive current load across the resistors, they tend to heat up considerably, causing the soldered component leads to become unstable and loose, resulting poor solder joint prevents proper operation of the circuitry, resulting in a blank display or very dim display.

This display board was removed from a car with 47,000 miles. You can see the heat damage to the resistor connections.

Repairing this damage involves removal of the resistors and sometimes grafting a copper footprint conductor onto the original trace on the circuit board. The excessive heat from these resistors burn the fiberglass PC board and surrounding copper solder pad and traces attached to the pad. New design resistors are then used to replace the old technology.

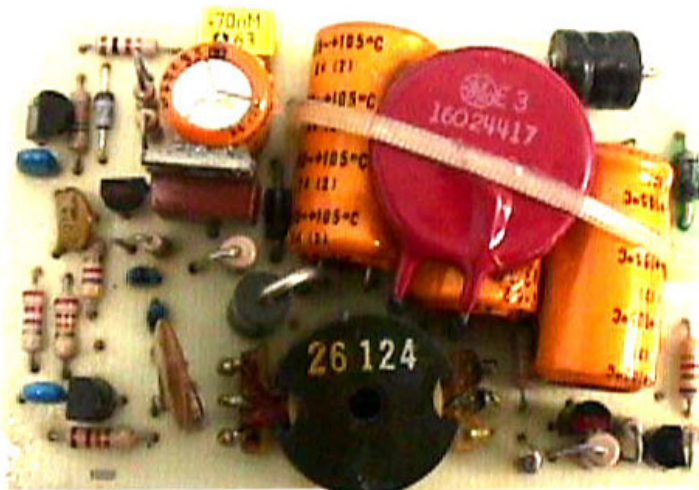
Another common problem with the digital cluster is when the entire cluster goes blank, where there are no segments illuminated. Typically, this is caused by a failed power supply which is piggy-backed to the processor PC board. The power supply on these digital clusters supplies 5 volts for the logic circuit and 18 volts for the VFD display system. There are two slightly different power supplies used between the years; the 1984 - 1985 model years use a supply with an external RF choke coil, mounted behind the cluster face, and the later 1986 - 1987 model years use an RF choke mounted directly to the power supply PC board.

Early power supply board using external RF choke remotely mounted.

When the “dead dash” condition is diagnosed, the defective power supply must be replaced. Caspers provides a newly-designed “switching” power supply that is much more efficient.

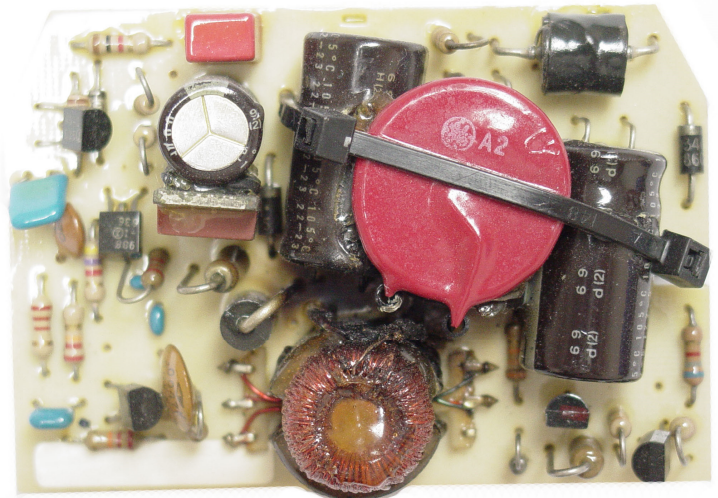
Later power supply with the RF choke mounted on top of the toroid transformer.

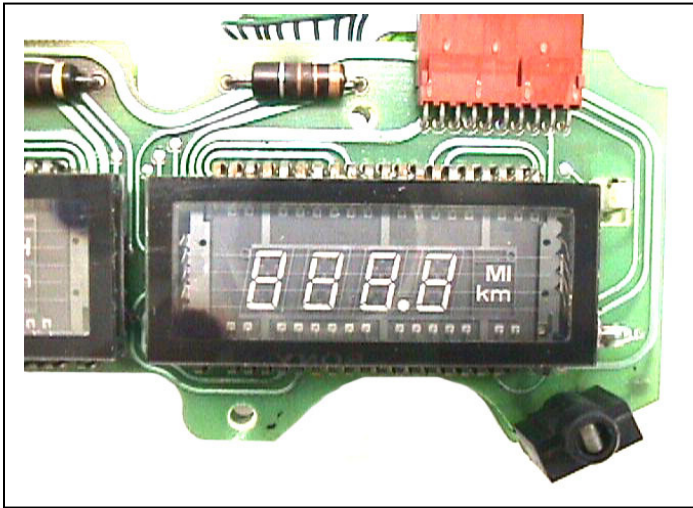
Trip Odometer VFD display mounted onto the display PC board.

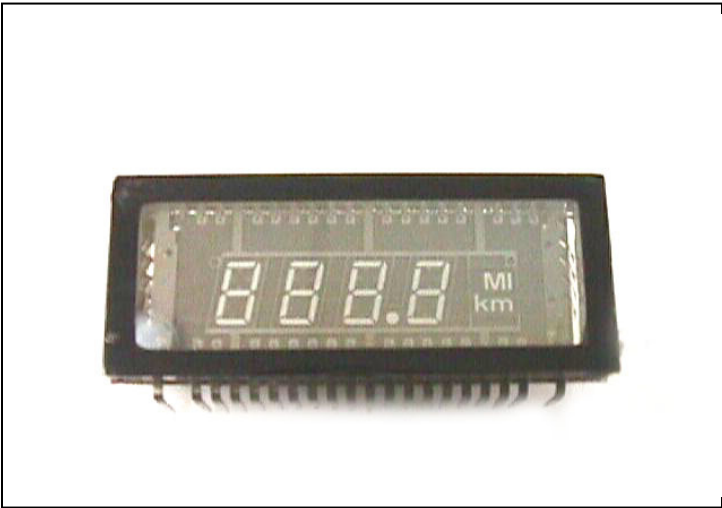
Another frequent problem with the cluster is a dead “ODOMETER” display. The VFD odometer display is a separate readout and is physically close to the KM/MPH reset knob and for this reason, is prone to physical stress which can break the fragile vacuum tube. Damage

occurs when the odometer reset button is pushed too hard, causing the PC board to flex and bend, stressing the display tube and fracturing the glass seal.

Fractured VFD display. Note the white spot in lower left corner.

When the display is damaged, the lower left corner turns white, indicating absence of vacuum in the display. When this happens, the VFD display must be replaced.

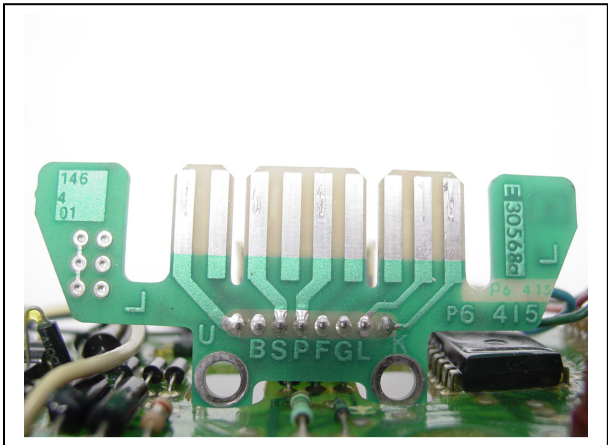
Occasionally a dash will become intermittent due to the connection from the digital cluster to the dash harness. The connection is made via an edge-type PC board connection to a specially designed connector. The edge connector uses printed fingers which are tin plated from the factory. In time, the tin plating becomes tarnished and oxidized, requiring cleaning and resurfacing.

This edge connector is affixed to the digital cluster and extends through the sub-base. If oxidation is present, the fingers must be cleaned and polished.

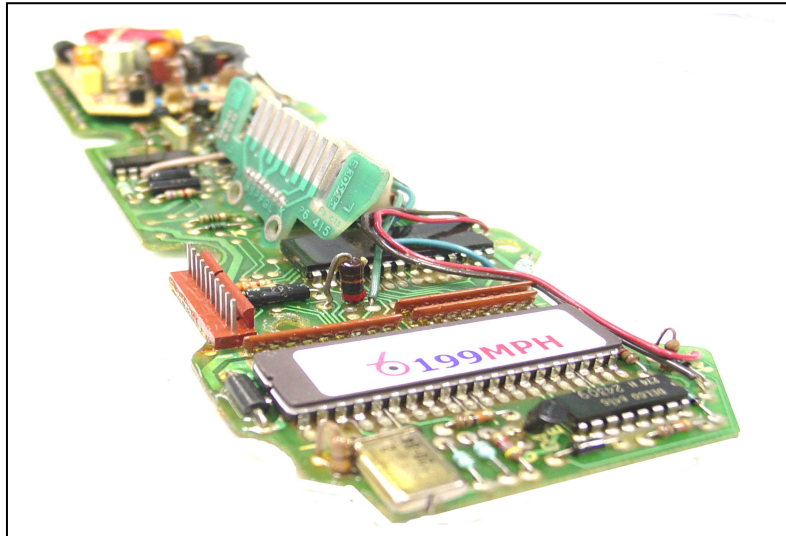
The digital dash was designed to indicate road speeds of up to 85 MPH. Beyond that, the dash would blink a consistent “85” but would not indicate actual MPH if the vehicle was traveling faster. A common upgrade involves a re-programmed replacement microprocessor chip which allows proper MPH to be displayed, up to the limit of the display, which is 199 MPH or KPH. The PC board shown below has been modified with the 199 MPH upgrade processor IC.

The new microprocessor must be soldered onto the circuit board. This involves special equipment and techniques.

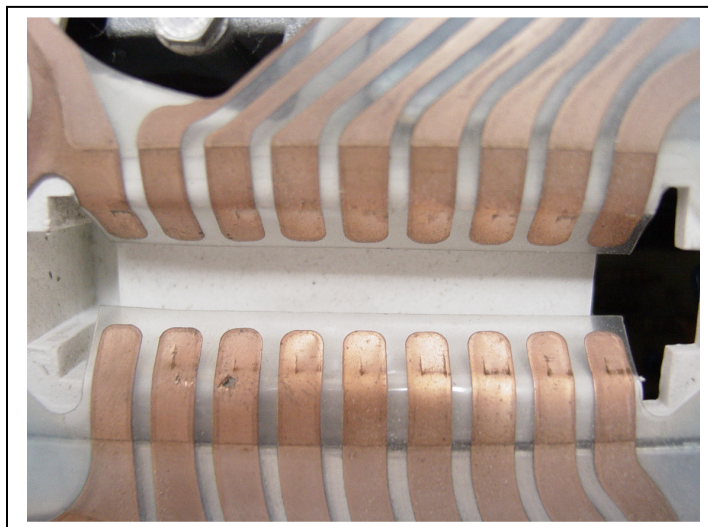
The flex board affixed to the rear of the dash cluster is susceptible to corrosion and tarnishing of the copper conductors, causing a poor electrical connection. Also, because of the contact design on the lamp holders, it is possible to actually rub through the copper conductors, causing an intermittent connection. Since the alternator requires field current which flows through the VOLTS lamp, a bad connection here could prevent the alternator from charging the battery.

To minimize electrical problems with this flex board, it is recommended that you remove the cluster, and remove all of the lamp holders, then gently rub all exposed copper conductors with a pencil eraser to remove oxidation from these conductors. This should also be done in the plug connection area as shown below:

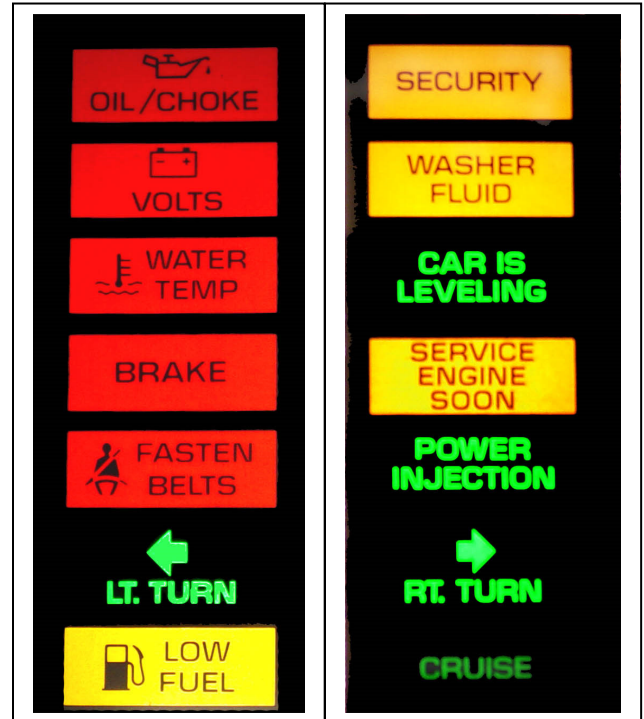
Scratches can develop from years of cleaning the dash lens and surrounding indicator lenses. They are made of soft acrylic plastic and scratch easily. The best way we have found to remove minor scratches and swirl marks is to use a product designed to remove scratches from CD's and DVD's. Here is one such product:

These are the Telltale filters found on either side of the dash cluster. Minor scratches and swirl marks can easily be removed.

Carefully remove the cluster lens and both of the Telltale filter lenses on either side of the dash. Follow the instructions with the scratch remover product and don't rub too hard as the scratch remover is slightly abrasive. **DO NOT ATTEMPT TO CLEAN THE BLACK PAINTED DIAL OF THE CLUSTER FACE.** The semi-flat painted finish on the dash dial is very sensitive to any type of abrasion and will show fingerprints and smudges **VERY** easily. It is best left alone and should be cleaned with only dry compressed air.
