DIGITAL DASH CLUSTER 1984-1987 BUICK REGAL

THE BUICK REGAL, GRAND NATIONAL TURBO, T-TYPE AND LIMITED WERE ALL OFFERED A DIGITAL DASH CLUSTER OPTION THAT UTILIZED VACUUM FLUORESCENT DISPLAYS. ALTHOUGH THE CIRCUITRY AND COMPONENTRY ARE COMMON BETWEEN THE MODELS, THERE ARE SOME SUBTLE DIFFERENCES IN THE DASH LAYOUT. THIS ARTICLE WILL SPELL OUT THESE DIFFERENCES AND SHOW YOU SOME OF THE ELECTRICAL FAULTS UNCOVERED IN THE REPAIR AND RESTORATION OF THESE DASH CLUSTERS.

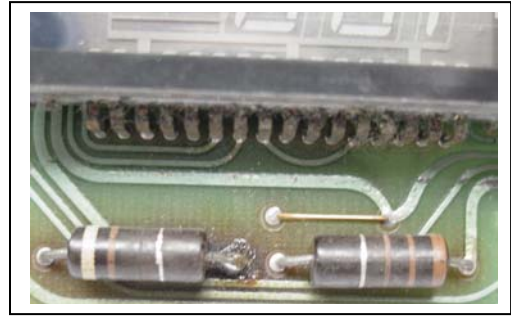
Over a course of time and temperature extremes, components on these dash clusters had a tendency to fail, causing many different problems to surface. Perhaps the most common problem is when the MPH segment goes dim intermittently, or goes off completely. This is almost always caused by a pair of overheated resistors soldered to the display PC board. The purpose of these resistors is to reduce brightness of the VFD displays for night driving.

Because of the excessive current load across the resistors, they tend to heat up considerably, causing the soldered component leads to become unstable and loose. The resulting poor solder joint reduces the display brightness well below where it should be, causing a blank display or very dim display.

This display board was removed from a car with 47,000 miles. You can see the heat damage to the resistor connections.

Repairing this damage involves removal of the resistors and sometimes grafting a copper footprint conductor onto the original trace on the circuit board. The excessive heat from these resistors burn the fiberglass PC board and surrounding copper solder pad and traces attached to the pad.

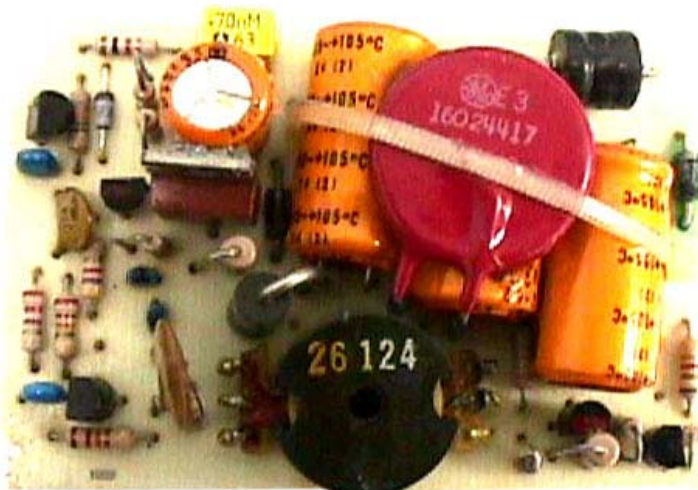
Another common problem with the digital cluster is when the entire cluster goes blank, where there are no segments illuminated. Typically, this is caused by a failed power supply which is piggy-backed to the processor PC board. The power supply on these digital clusters supplies 5 volts for the logic circuit and 18 volts for the VFD display system. There are two slightly different power supplies used between the years; the 1984 and 1985 model years use a supply with an external RF choke coil, mounted behind the cluster face, and the later 1986-1987 model years use an RF choke mounted directly to the power supply PC board.

Early power supply board using external RF choke remotely mounted.

When the “dead dash” condition is diagnosed, the defective power supply must be replaced.

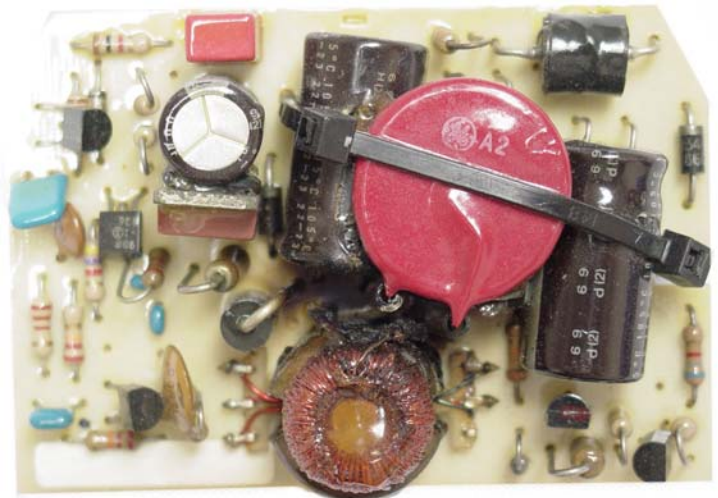
Later power supply with the RF choke mounted on top of the toroid transformer.

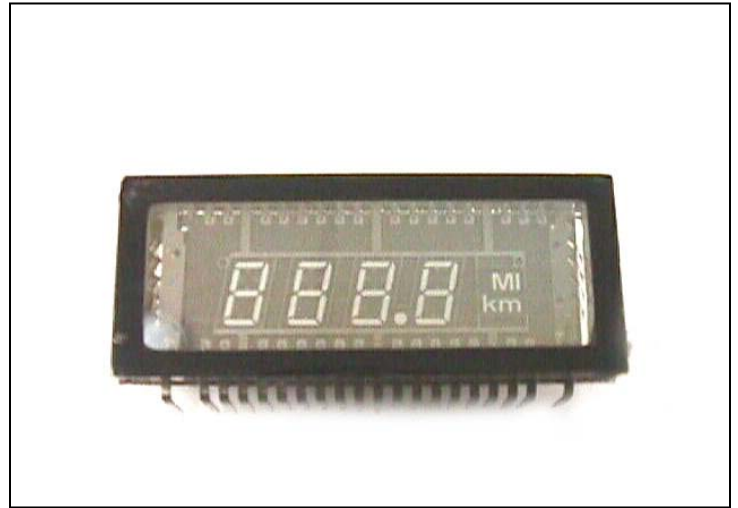
Another frequent problem with the cluster is a dead “ODOMETER” display. The VFD odometer display is a separate readout and is physically close to the KM/MPH reset knob and for this reason, is prone to physical stress which can break the fragile vacuum tube. Damage occurs when the odometer reset button is pushed too hard, causing the PC board to flex and bend, stressing the display tube and fracturing the glass seal.

Fractured VFD display. Note the white spot in lower left corner.

When the display is damaged, the lower left corner turns white, indicating absence of vacuum in the display. When this happens, the VFD display must be replaced.

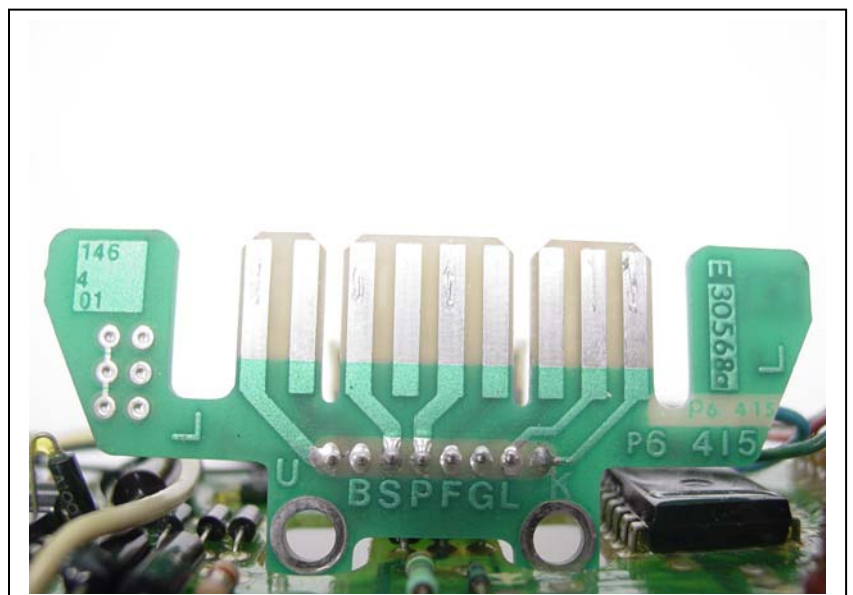
Occasionally a dash will become intermittent due to the connection from the digital cluster to the dash harness. The connection is made via an edge-type PC board connection to a specially made connector. The edge connector uses printed fingers which are tin plated from the factory. In time, the tin plating becomes tarnished and oxidized, requiring cleaning and resurfacing.

This edge connector is affixed to the digital cluster and extends through the sub-base. If oxidation is present, the fingers must be cleaned and polished.

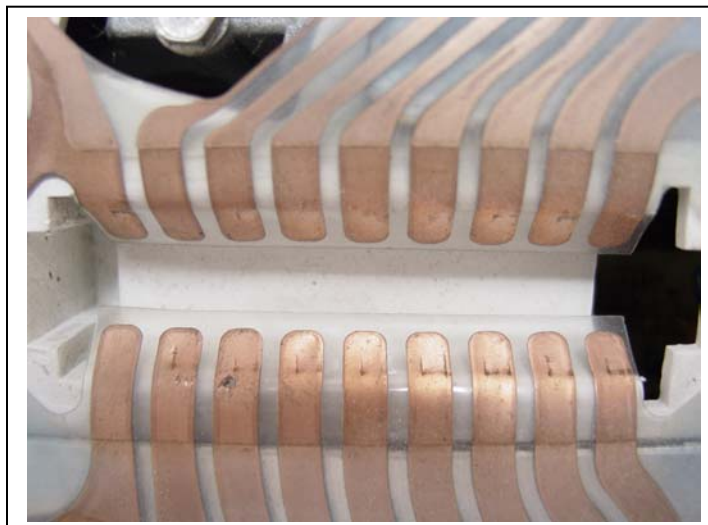
The flex board affixed to the rear of the dash cluster is susceptible to corrosion and tarnishing of the copper conductors, causing a poor electrical connection. Also, because of the contact design on the lamp holders, it is possible to actually rub through the copper conductors, causing an intermittent connection. Since the alternator requires field current which flows through the VOLTS lamp, a bad connection here could prevent the alternator from charging the battery.

To minimize electrical problems with this flex board, it is recommended that you remove the cluster, and remove all of the lamp holders, then gently rub all exposed copper conductors with a pencil eraser to remove oxidation from these conductors. This should also be done in the plug connection area as shown below:

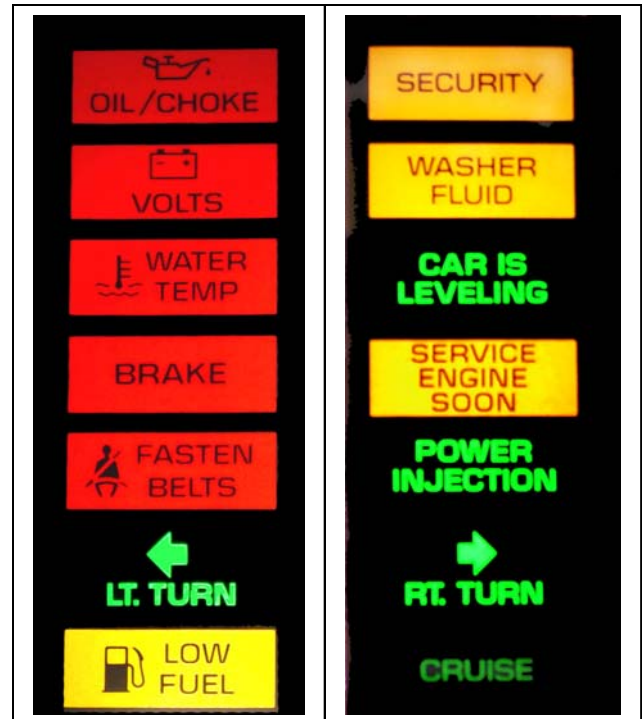
Scratches can develop from years of cleaning the dash lens and surrounding indicator lenses. They are made of soft acrylic plastic and scratch easily. The best way we have found to remove minor scratches and swirl marks is to use a product designed to remove scratches from CD's and DVD's. Here is one such product:

These are the Telltale filters found on either side of the dash cluster. Minor scratches and swirl marks can easily be removed.

Carefully remove the cluster lens and both of the Telltale filter lenses on either side of the dash. Follow the instructions with the scratch remover product and don't rub too hard as the scratch remover is slightly abrasive. **DO NOT ATTEMPT TO CLEAN THE BLACK PAINTED DIAL OF THE CLUSTER FACE.** The semi-flat painted finish on the dash dial is very sensitive to any type of abrasion and will show fingerprints and smudges **VERY** easily. It is best left alone and should be cleaned with only dry compressed air.
