DIGITAL DASH CLUSTER

1984-1987 BUICK REGAL and RIVIERA

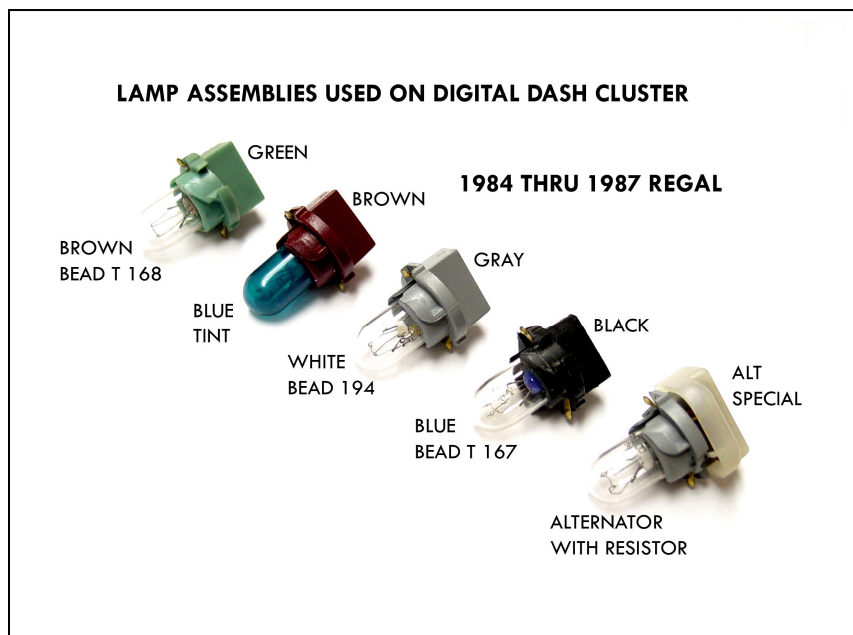
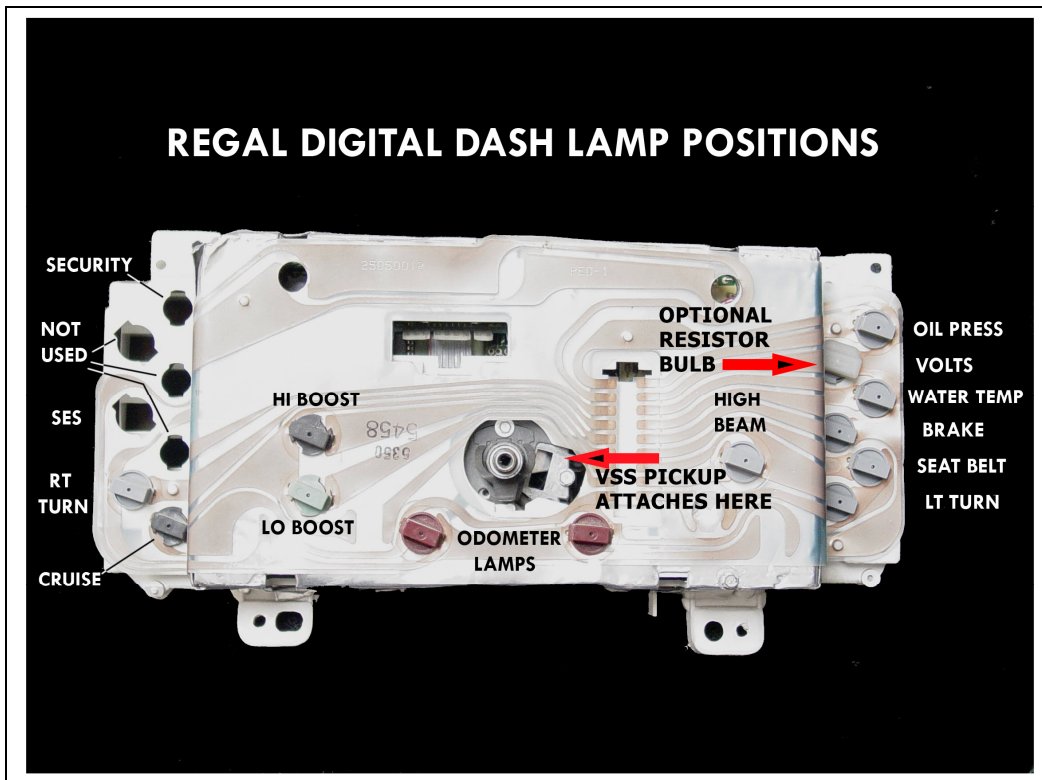
The indicator lights (turn signal, Volts, Service Engine Soon, etc.) that are part of the dash cluster are not directly related to the digital dash but complete the dash display. There are three basic types of “wedge” indicator lamps found on the dash. The brightest lamps have a green holder, type 168 – brown bead, and dimmest bulbs have a black holder with type 167 – blue bead. The gray holders use type 194 wedge lamps (white bead) which is about mid brightness. There is a pair of blue tinted bulbs in brown holders that illuminate the mechanical odometer on the dash cluster. Also, on some vehicles, there is an alternator indicator (VOLTS) that is specially designed with a 470 ohm carbon resistor across its contacts. This bulb has a white cover on the rear of the holder. This special bulb is designed to maintain field current to the alternator in the event that the bulb should burn out (which would cause the alternator to stop charging).

The flex board affixed to the rear of the dash cluster is susceptible to corrosion and tarnishing of the copper conductors, causing a poor electrical connection. Also, because of the contact design on the lamp holders, it is possible to actually rub through the copper conductors, causing an intermittent connection. Since the alternator requires field current which flows through the VOLTS lamp, a bad connection here could prevent the alternator from charging the battery.

To minimize electrical problems with this flex board, it is recommended that you remove the cluster, and remove all of the lamp holders, then gently rub all exposed copper conductors with a pencil eraser to remove oxidation from these conductors. This should also be done in the plug connection area as shown below:

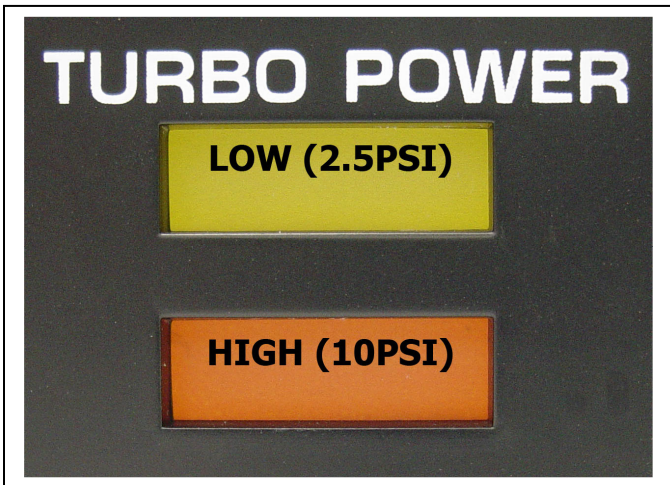
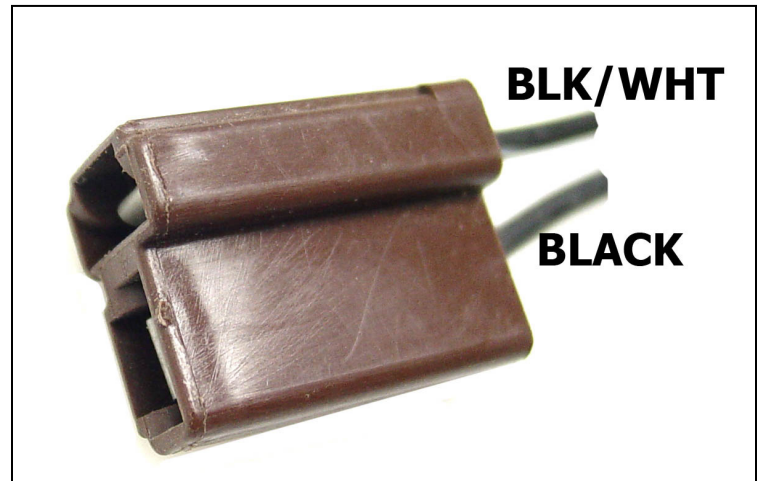
Turbo boost levels are indicated by a simple, two-light display located at the lower right side of the dash, labeled "TURBO POWER". This design merely indicates low boost (in yellow) and high boost (in orange). The low boost is preset to illuminate the yellow lamp at 2.5PSI. The high boost is preset at 10PSI.

The control switch is located on the inner fender, passenger side, on the bracket that secures the FUEL, AC, and ESC modules. The switch itself is a grounding-type pressure switch with two terminals. The connector is a brown, two wire, unsealed female style.

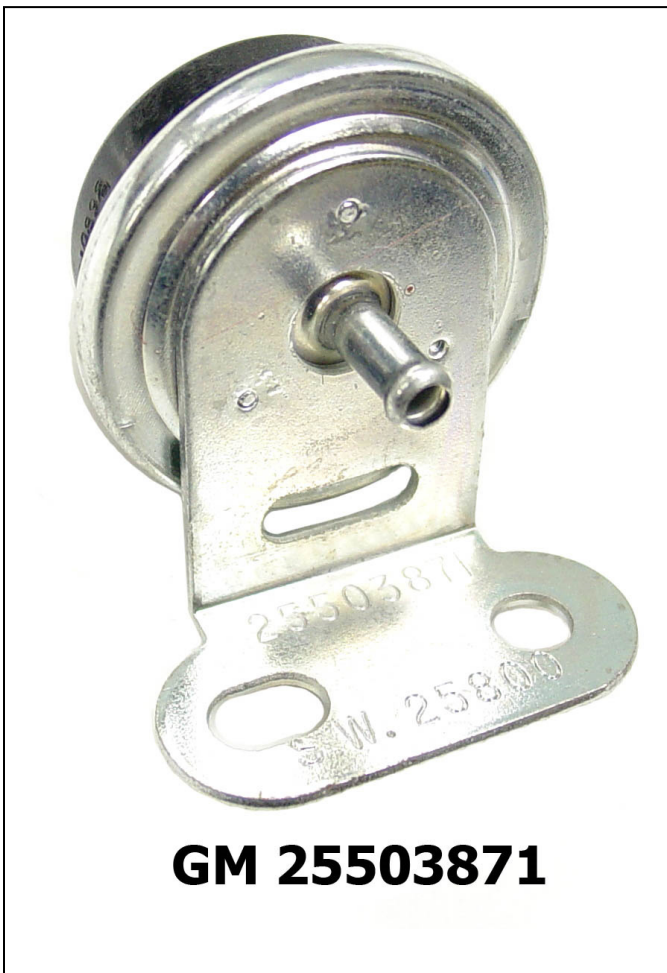
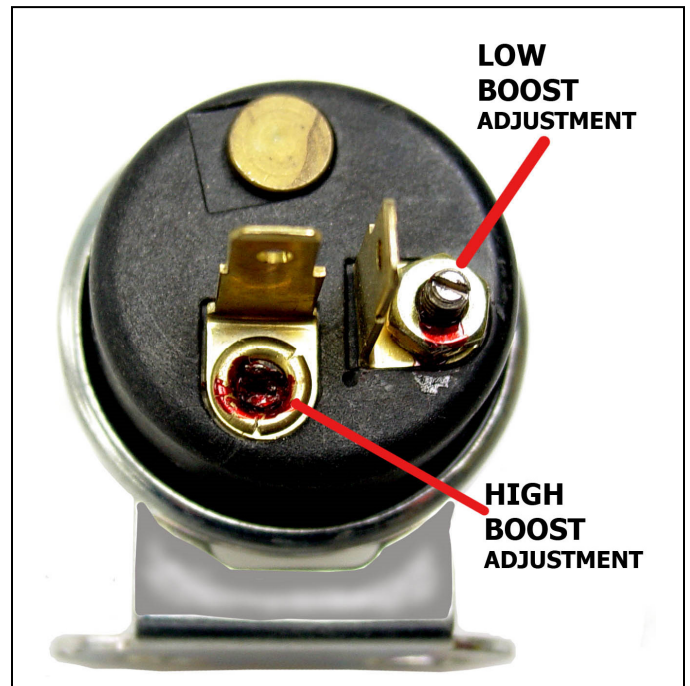
Pressure turn-on settings are preset from the factory. The pressure settings are adjusted using the set screws shown in this illustration. Adjustment can be checked using a hand pressure pump with accurate gauge and an ohmmeter.

Always check the vacuum hose connection to the switch for cracks and leaks when troubleshooting boost display malfunctions. A leak could prevent lights from illuminating.
