DIGITAL DASH CLUSTER 1984-1987 BUICK REGAL

THE BUICK REGAL, GRAND NATIONAL TURBO, T-TYPE AND LIMITED WERE ALL OFFERED A DIGITAL DASH CLUSTER OPTION THAT UTILIZED VACUUM FLUORESCENT DISPLAYS. ALTHOUGH THE CIRCUITRY AND COMPONENTRY ARE COMMON BETWEEN THE MODELS, THERE ARE SOME SUBTLE DIFFERENCES IN THE DASH LAYOUT. THIS ARTICLE WILL SPELL OUT THESE DIFFERENCES AND SHOW YOU SOME OF THE ELECTRICAL FAULTS UNCOVERED IN THE REPAIR AND RESTORATION OF THESE DASH CLUSTERS.

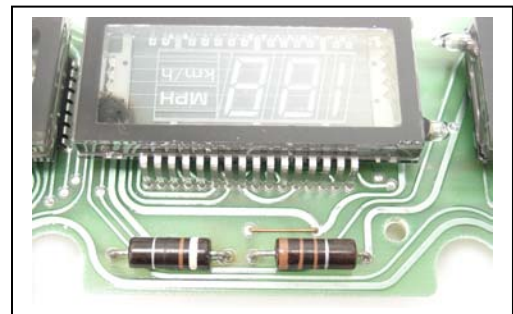
This is a “good” display board showing what the resistors should look like when soldered correctly. No solder joint discoloration here.

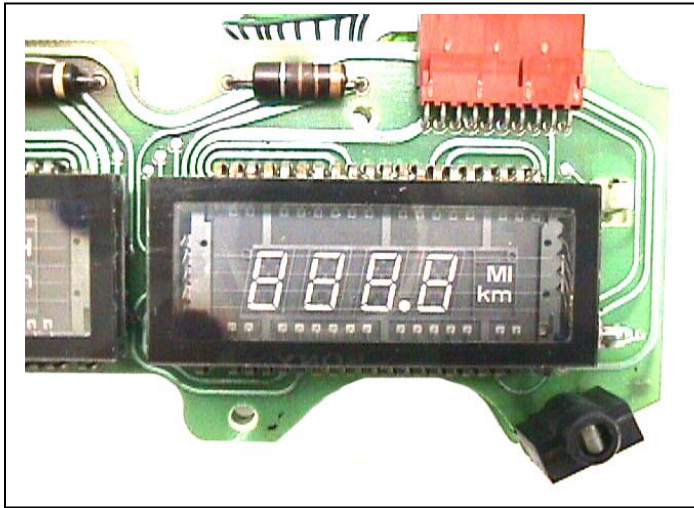
Another frequent problem with the cluster is a dead “ODOMETER” display. The VFD odometer display is a separate readout and is physically close to the KM/MPH reset knob and for this reason, is prone to physical stress which can break the fragile vacuum tube. Damage occurs when the odometer reset button is pushed too hard, causing the PC board to flex and bend, stressing the display tube and fracturing the glass seal.

Trip Odometer VFD display mounted onto the display PC board.

When the display is damaged, the lower left corner turns white, indicating absence of vacuum in the display. When this happens, the VFD display must be replaced.

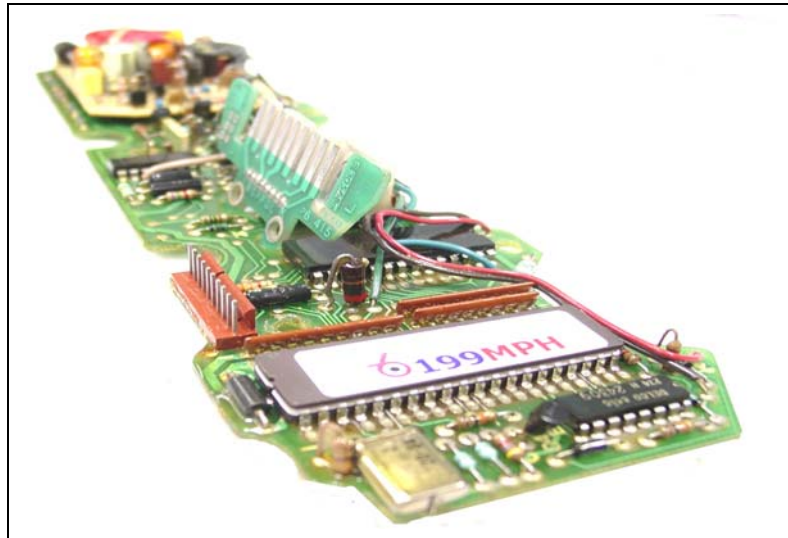
The digital dash was designed to indicate road speeds of up to 85 MPH. Beyond that, the dash would blink a consistent “85” but would not indicate actual MPH if the vehicle was traveling faster. A common upgrade involves a replacement microprocessor chip which allows proper MPH to be displayed, up to the limit of the display, 199 MPH. The PC board shown below has been modified with the 199 MPH upgrade processor IC.

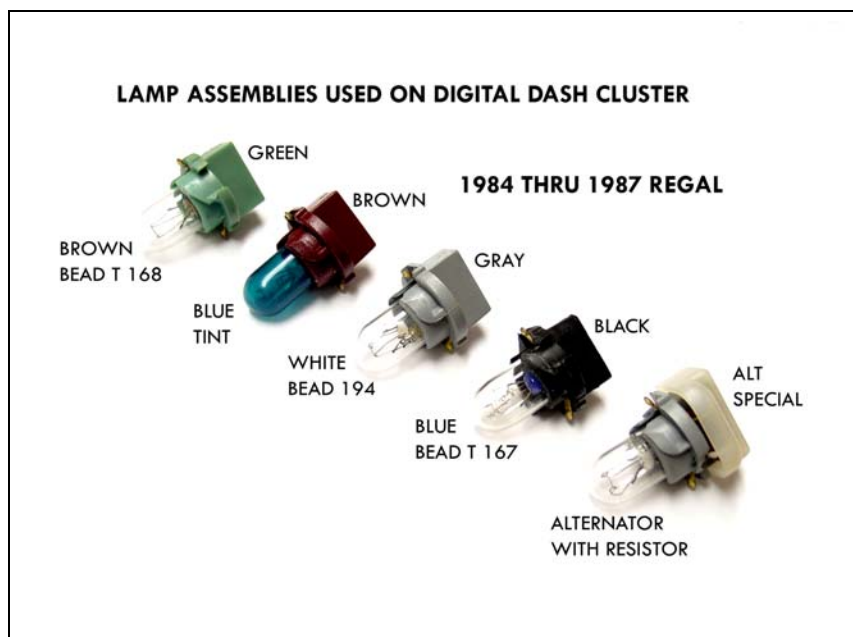
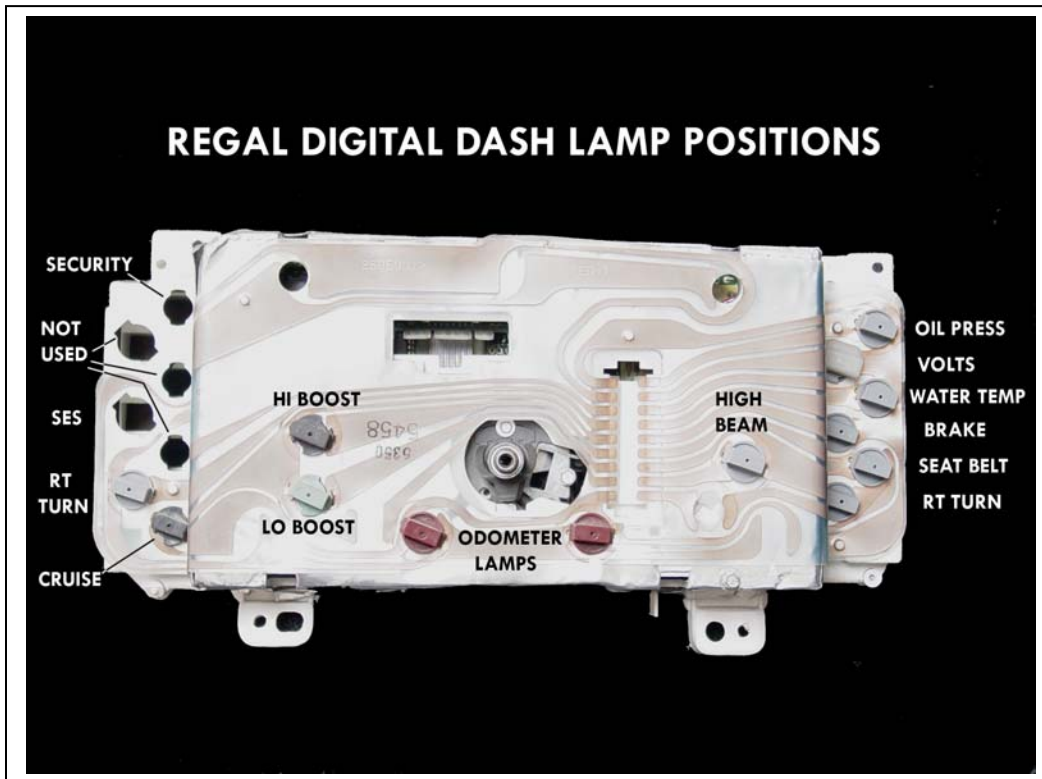
The indicator lights (turn signal, Volts, Service Engine Soon, etc.) that are part of the dash cluster are not directly related to the digital dash but complete the dash display. There are three basic types of “wedge” indicator lamps found on the dash. The brightest lamps have a green holder, type 168 – brown bead, and dimmest bulbs have a black holder with type 167 – blue bead. The gray holders use type 194 wedge lamps (white bead) which is about mid brightness. There is a pair of blue tinted bulbs in brown holders that illuminate the mechanical odometer on the dash cluster. Also, on some vehicles, there is an alternator indicator (VOLTS) that is specially designed with a 470 ohm carbon resistor across its contacts. This bulb has a white cover on the rear of the holder. This special bulb is designed to maintain field current to the alternator in the event that the bulb should burn out (which would cause the alternator to stop charging).

The flex board affixed to the rear of the dash cluster is susceptible to corrosion and tarnishing of the copper conductors, causing a poor electrical connection. Also, because of the contact design on the lamp holders, it is possible to actually rub through the copper conductors, causing an intermittent connection. Since the alternator requires field current which flows through the VOLTS lamp, a bad connection here could prevent the alternator from charging the battery.

To minimize electrical problems with this flex board, it is recommended that you remove the cluster, and remove all of the lamp holders, then gently rub all exposed copper conductors with a pencil eraser to remove oxidation from these conductors. This should also be done in the plug connection area as shown below:

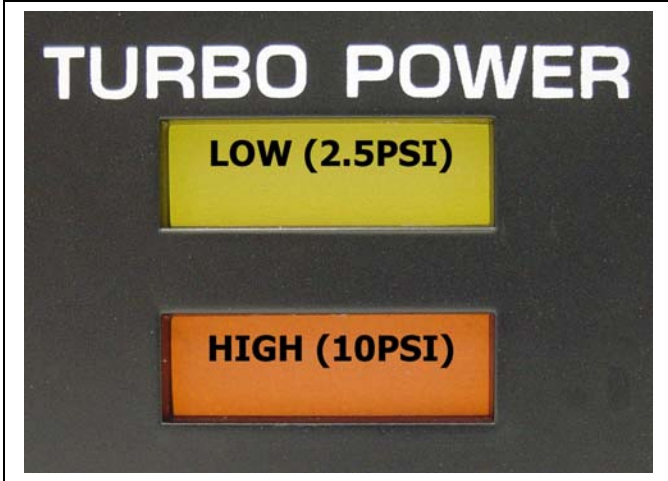
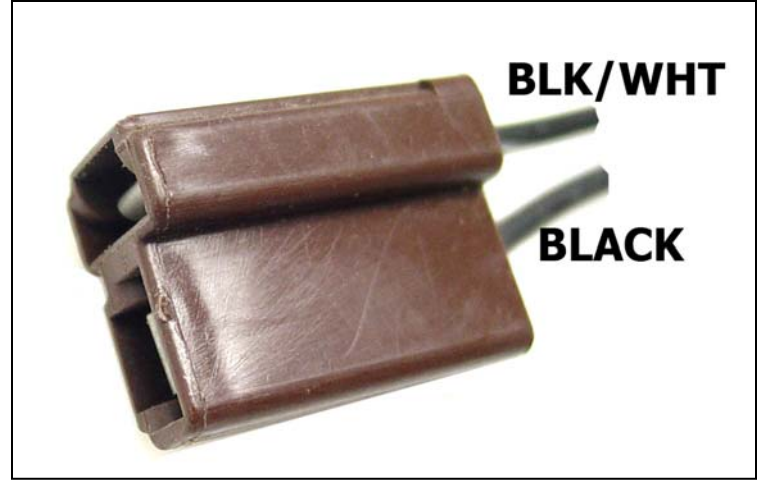
Turbo boost levels are indicated by a simple, two-light display located at the lower right side of the dash, labeled "TURBO POWER". This design merely indicates low boost (in yellow) and high boost (in orange). The low boost is preset to illuminate the yellow lamp at 2.5PSI. The high boost is preset at 10PSI.

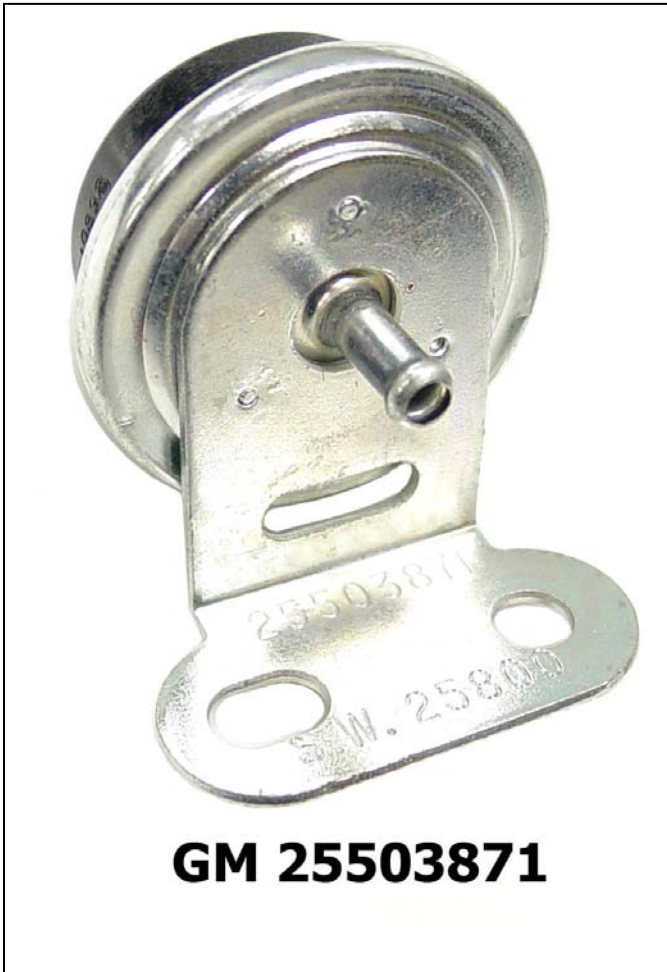
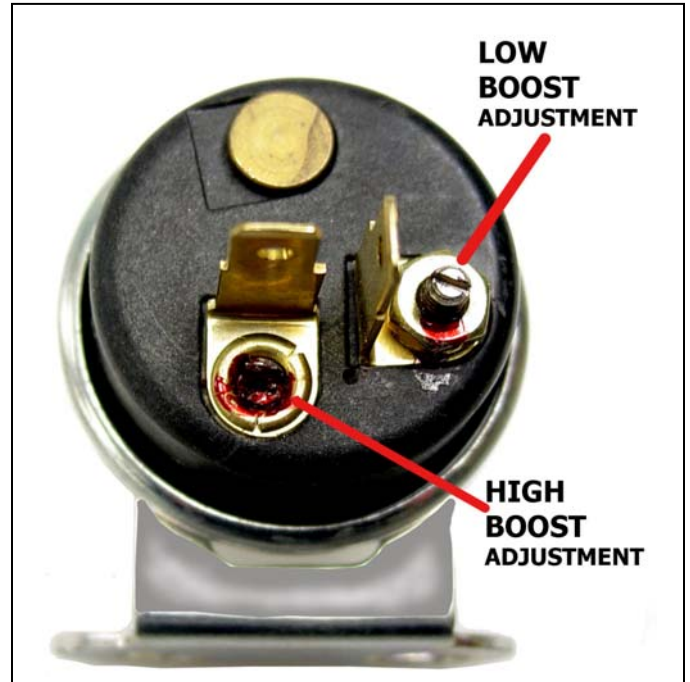
The control switch is located on the inner fender, passenger side, on the bracket that secures the FUEL, AC, and ESC modules. The switch itself is a grounding-type pressure switch with two terminals. The connector is a brown, two wire, unsealed female style.

Pressure turn-on settings are preset from the factory. The pressure settings are adjusted using the set screws shown in this illustration. Adjustment can be checked using a hand pressure pump with accurate gauge and an ohmmeter.

Always check the vacuum hose connection to the switch for cracks and leaks when troubleshooting boost display malfunctions. A leak could prevent lights from illuminating.

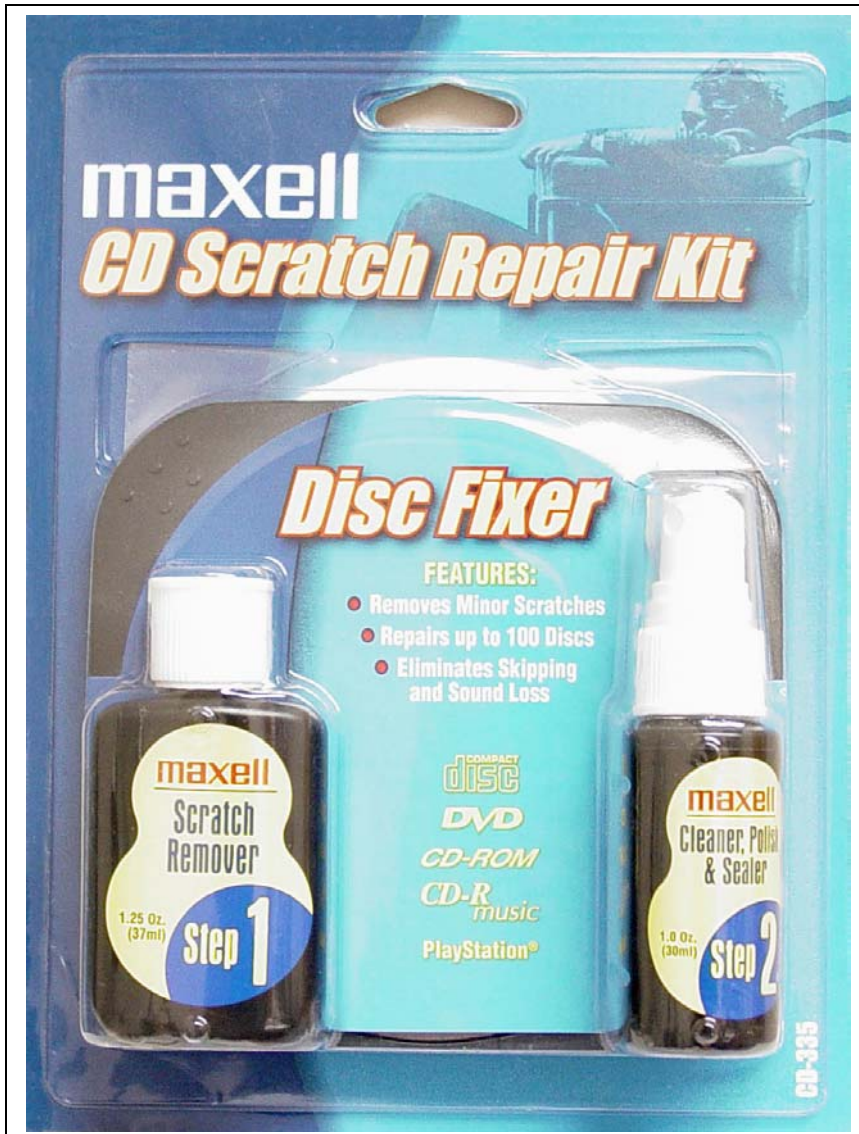
Scratches can develop from years of cleaning the dash lens and surrounding indicator lenses. They are made of soft acrylic plastic and scratch easily. The best way we have found to remove minor scratches and swirl marks is to use a product designed to remove scratches from CD's and DVD's. Here is one such product:

Carefully remove the cluster lens and both of the Telltale filter lenses on either side of the dash. Follow the instructions with the scratch remover product and don't rub too hard as the scratch remover is slightly abrasive. **DO NOT ATTEMPT TO CLEAN THE BLACK PAINTED DIAL OF THE CLUSTER FACE.** The semi-flat painted finish on the dash dial is very sensitive to any type of abrasion and will show fingerprints and smudges **VERY** easily. It is best left alone and should be cleaned with only dry compressed air.
